**Elliott Bay/Duwamish Restoration Program:
Year 2 Intertidal Habitat Projects Monitoring Report**

September 2003

Report prepared for the Elliott Bay/Duwamish Restoration Program Panel

By: U.S. Fish and Wildlife Service
Western Washington Fish and Wildlife Office
Lacey, Washington

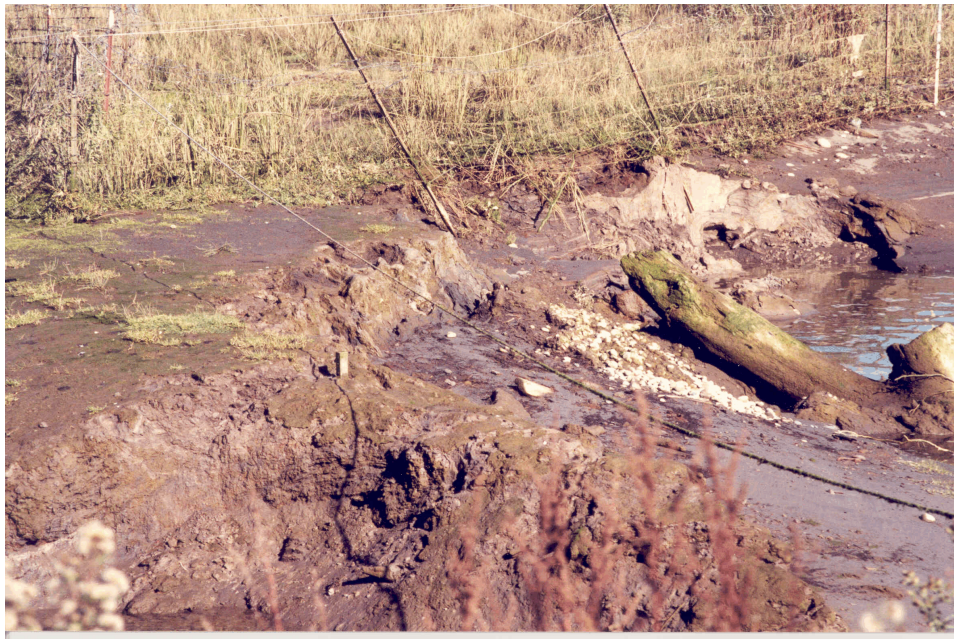
During the previous year, the Hamm Creek Estuary restoration site experienced significant erosion of the instream channel. A topographic survey with a Spectra-Physics® Laserplane 500 laser level was completed just prior to the onset of this erosion in 2001, and data from the survey has been stored in GIS/ArcView software for further analysis. Since that time sediments at the Hamm Creek Estuary have continued to erode, most noticeably along the north bank of the creek near its confluence with the Duwamish River (Figure 5).

Figure 5. View of eroding bank of Hamm Creek Estuary, Duwamish River, looking east, in fall 2002. Note hanging fence posts.

While Herring's House appears to be stable, erosion continues to be a concern at the Hamm Creek Estuary. Most of the erosion appears to be occurring in the intertidal area on the northern side of the creek, downstream of where it begins to flow parallel to the mainstem Duwamish River. The most noticeable movement of sediments is located on the northern bank of the lower mouth of Hamm Creek, where much of the subsurface wood and other materials (presumably placed during construction to stabilize the sediments on the peninsula) have become exposed. Efforts to stabilize the area, including placement of cobble, boulders, and large woody debris, were made in 2001 by U.S. Army Corps of Engineers. Cobble (64-256 mm) and boulders (>256 mm) were placed within the mouth of the channel along with four pieces of large woody debris (base diameter approximately 70 cm) with rootwads (Figure 6). These attempts to prevent further erosion have not corrected the situation. In October 2002, rebar was installed for elevation surveys on the northern shore of Hamm Creek, near 12.0 ft MLLW; by December 2002, the sediment level adjacent to the rebar had dropped by approximately one inch. By fall 2002, continued erosion of sediments had dislodged one of the fence posts along the northern shore of the mouth of Hamm Creek, and further erosion may soon threaten the integrity of the goose exclusion barrier. The erosion at the site has been documented by photography in 2001 and 2002. Preliminary Total Station elevation surveys were initiated and may be continued in the coming year based on need and available resources.

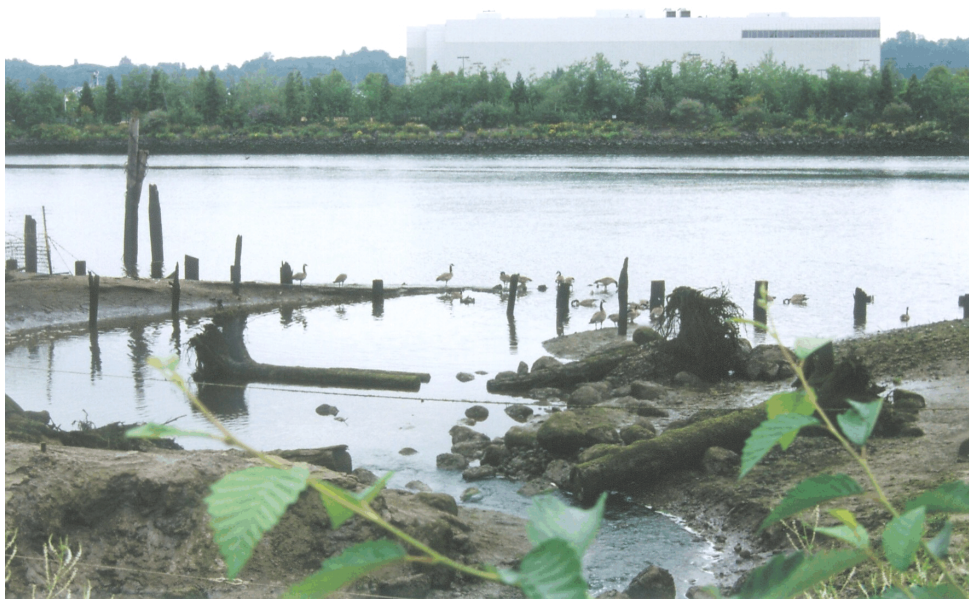
Figure 6. Placement of large woody debris, boulders and cobble in the Hamm Creek Estuary, Duwamish River, in 2001.
